Marshall Hydroelectric Project Disposition Study

City of Marshall

June 19, 2017

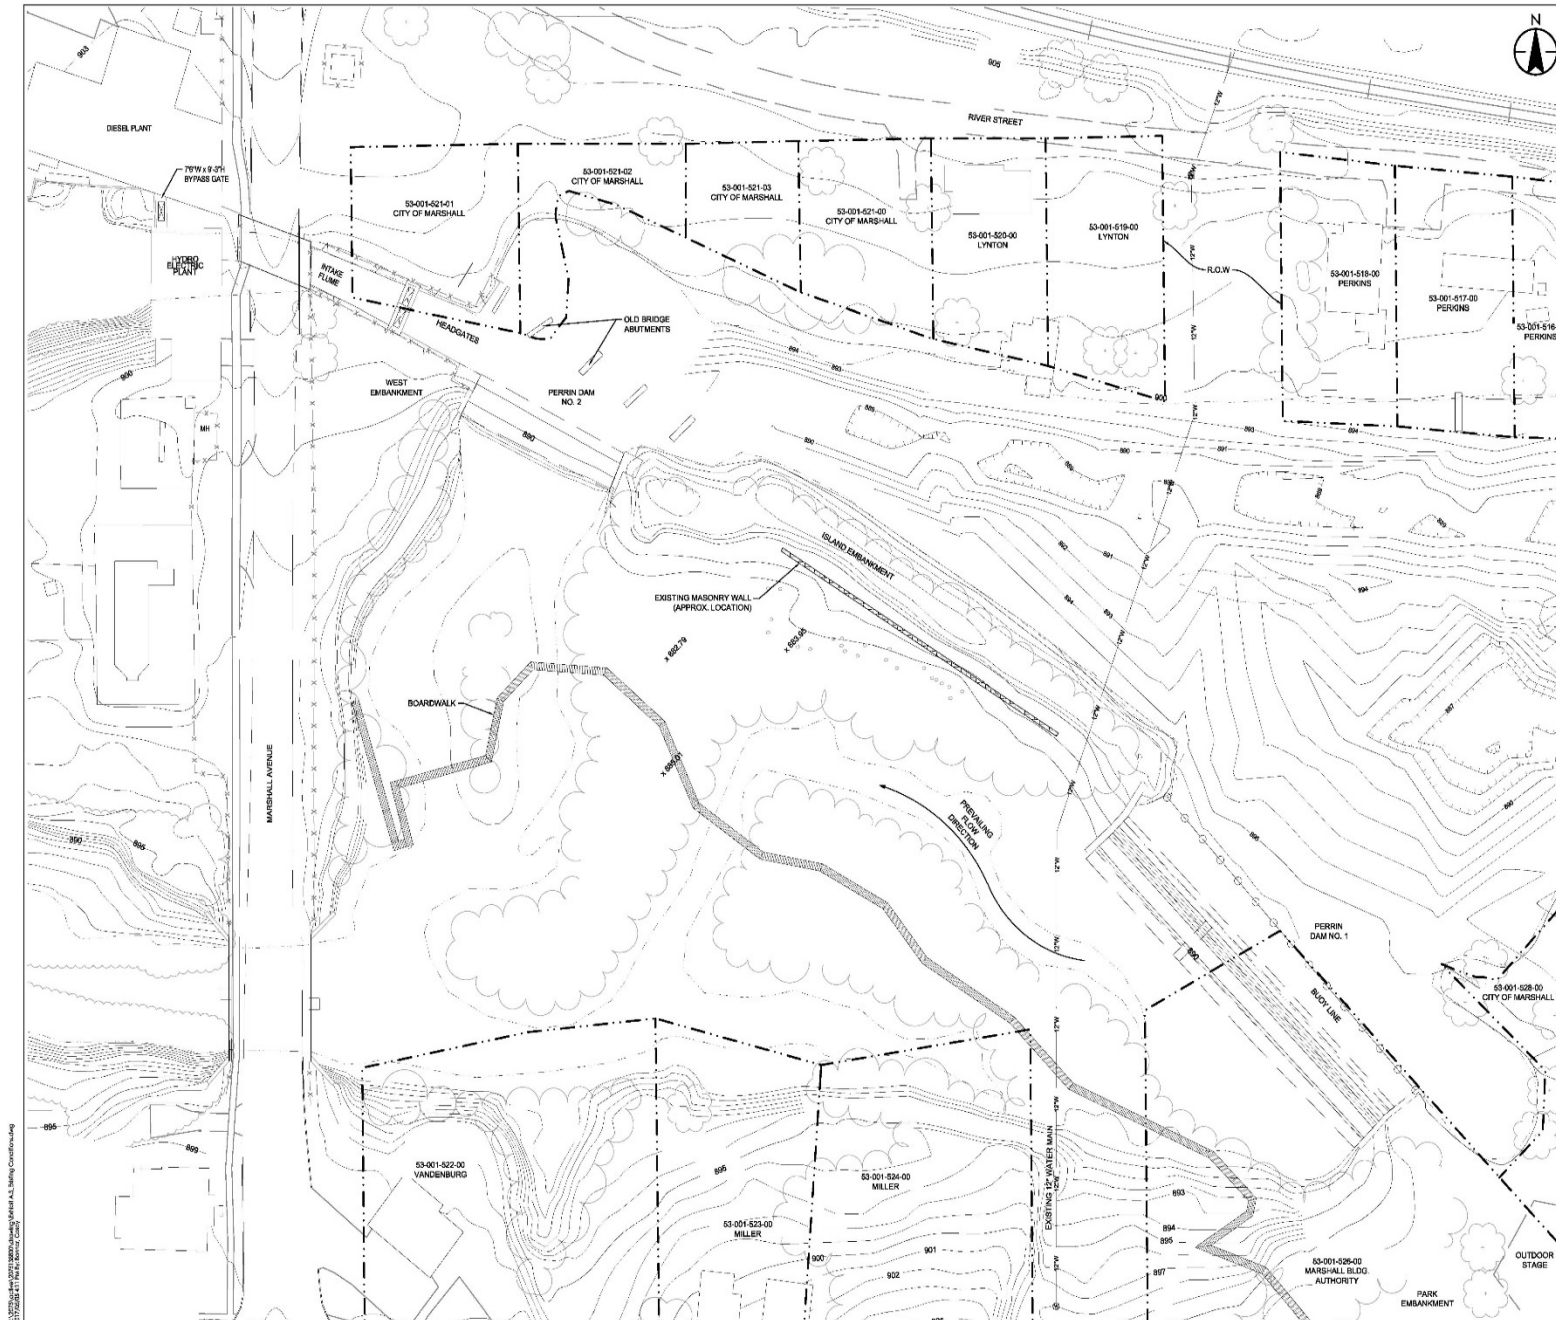
Figure A.3

Dam has structural and hydraulic issues

- Internal Erosion and Piping in Island Embankment
- Stability safety factor is too low

- Inadequate discharge capacity at maximum flood

Title
TOPOGRAPHY & EXISTING CONDITIONS

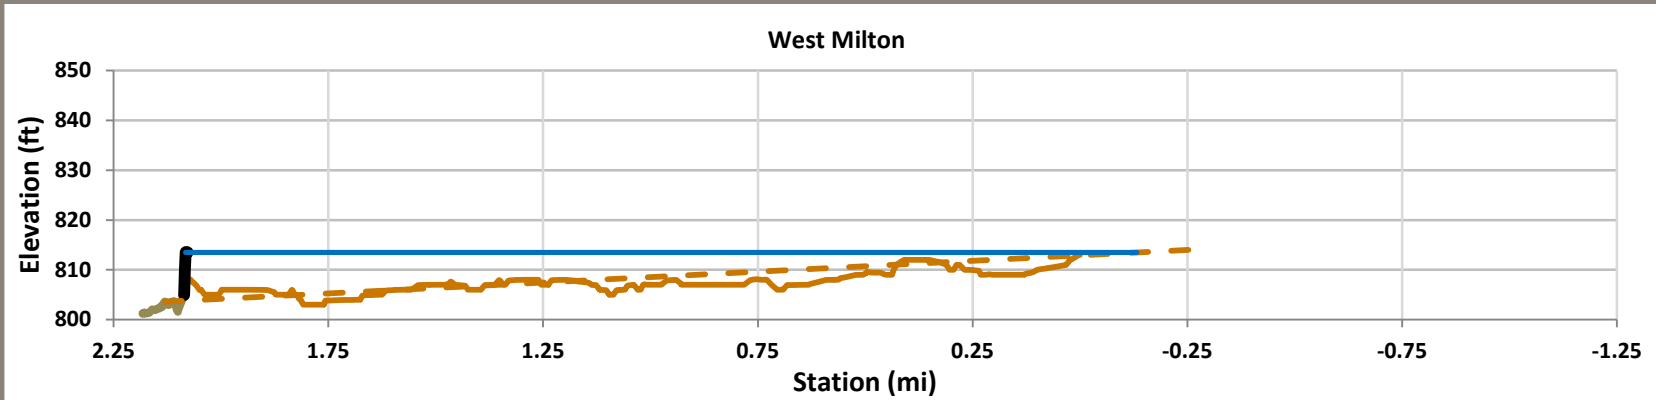
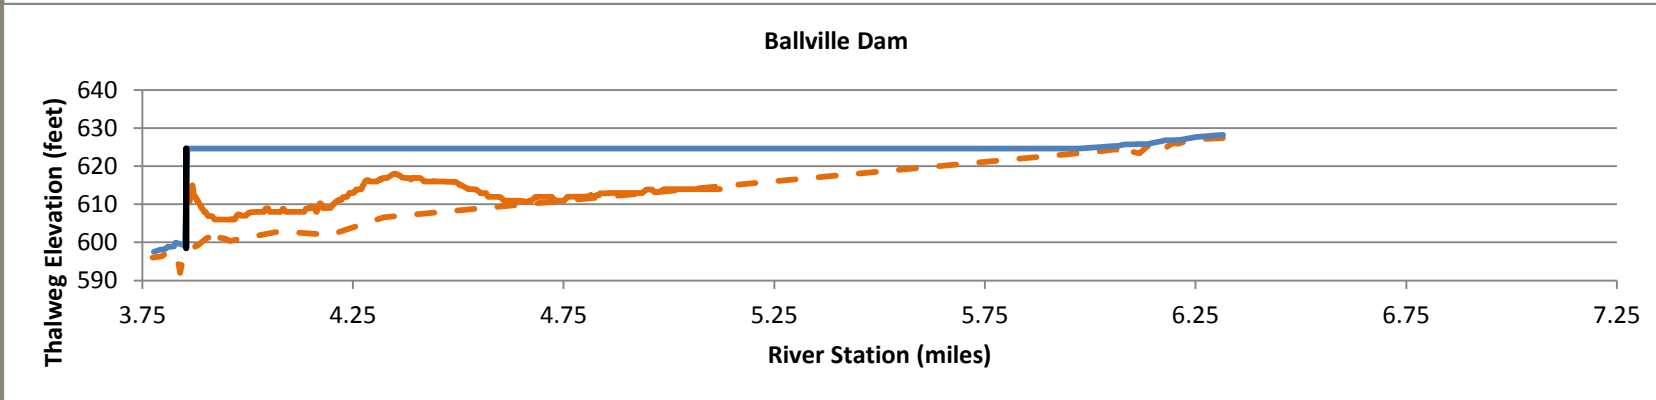
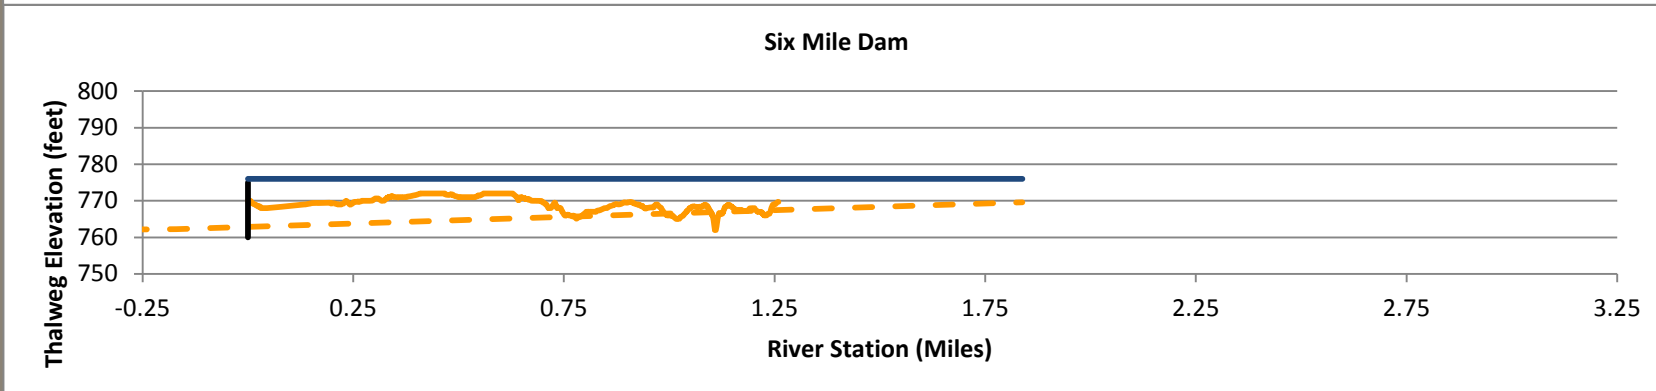
- Estimated 1.5 million cubic yards behind dam.

Sediment management - volume

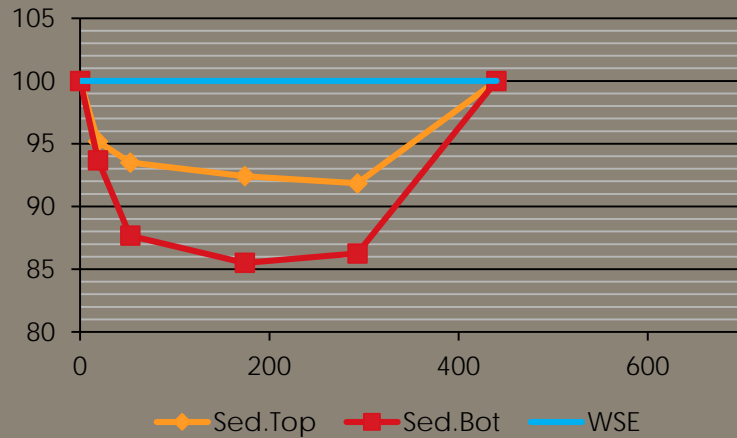
Section 6

Sediment management - volume

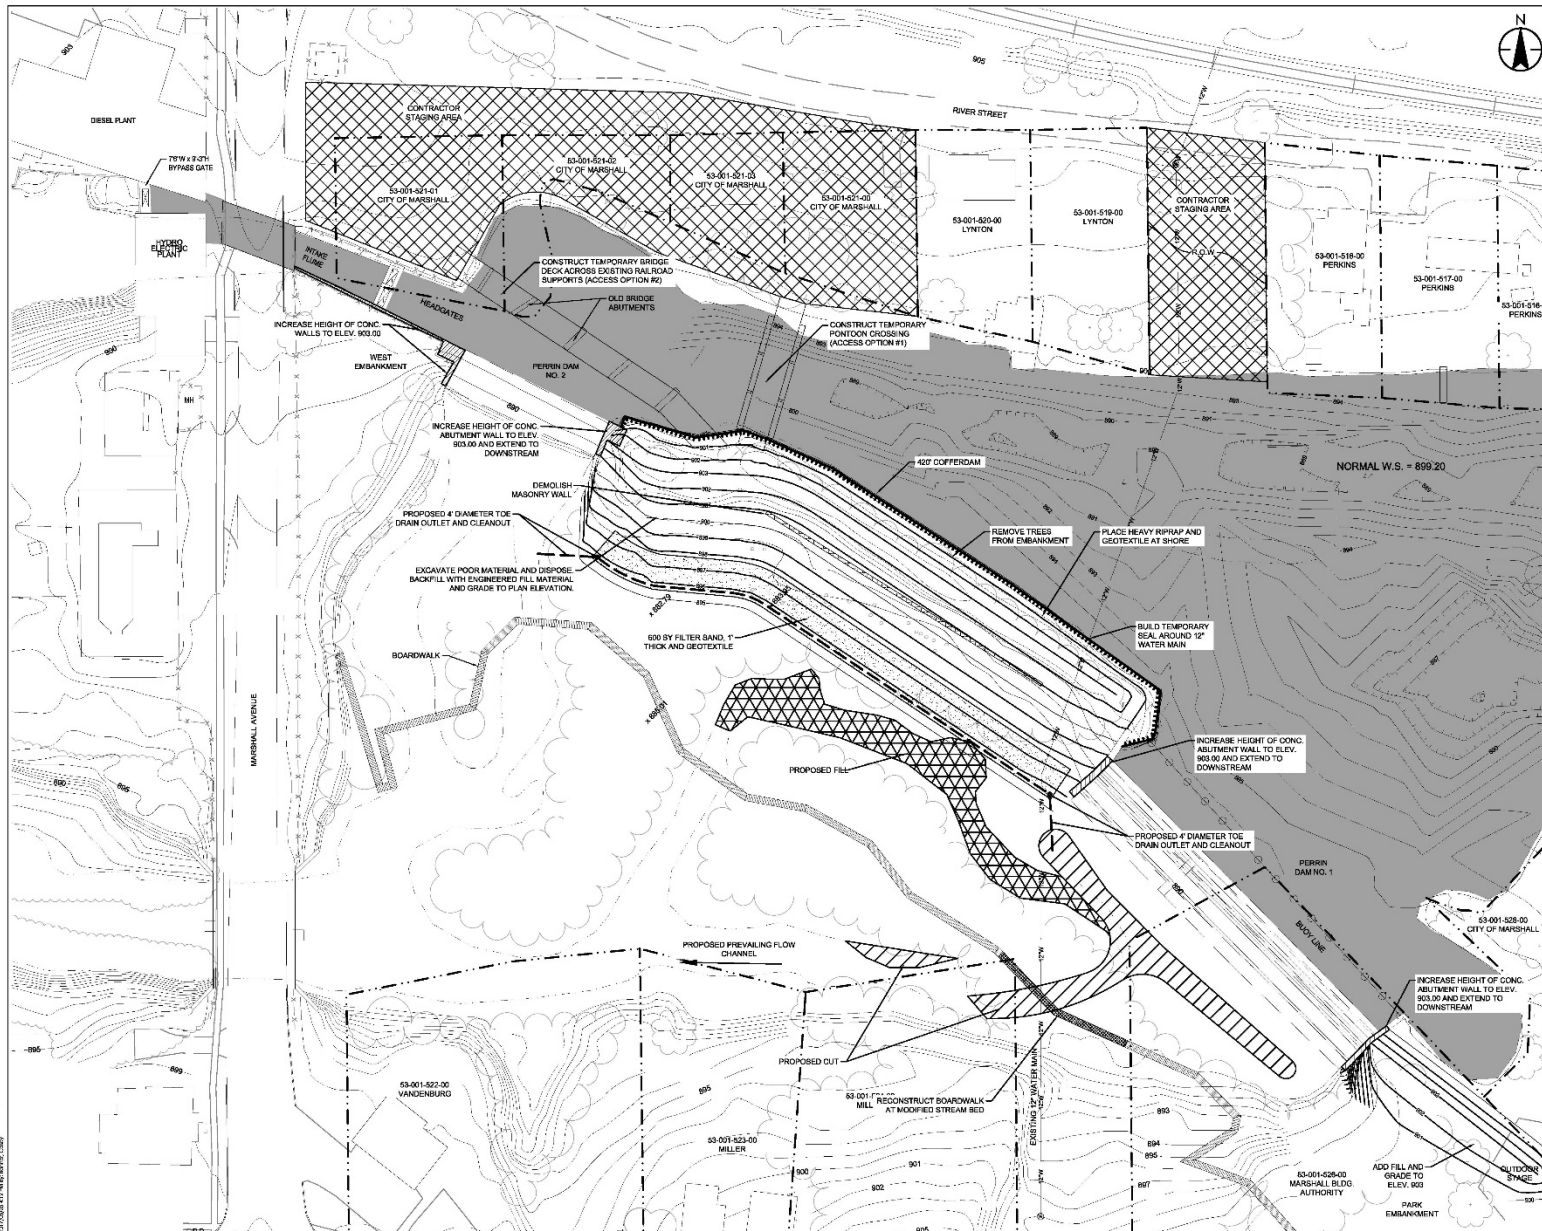
Figure D.1

Repair with cofferdam

COFFERDAM - ALTERNATIVE 1

Repair with Cofferdam

\$2.2 Million

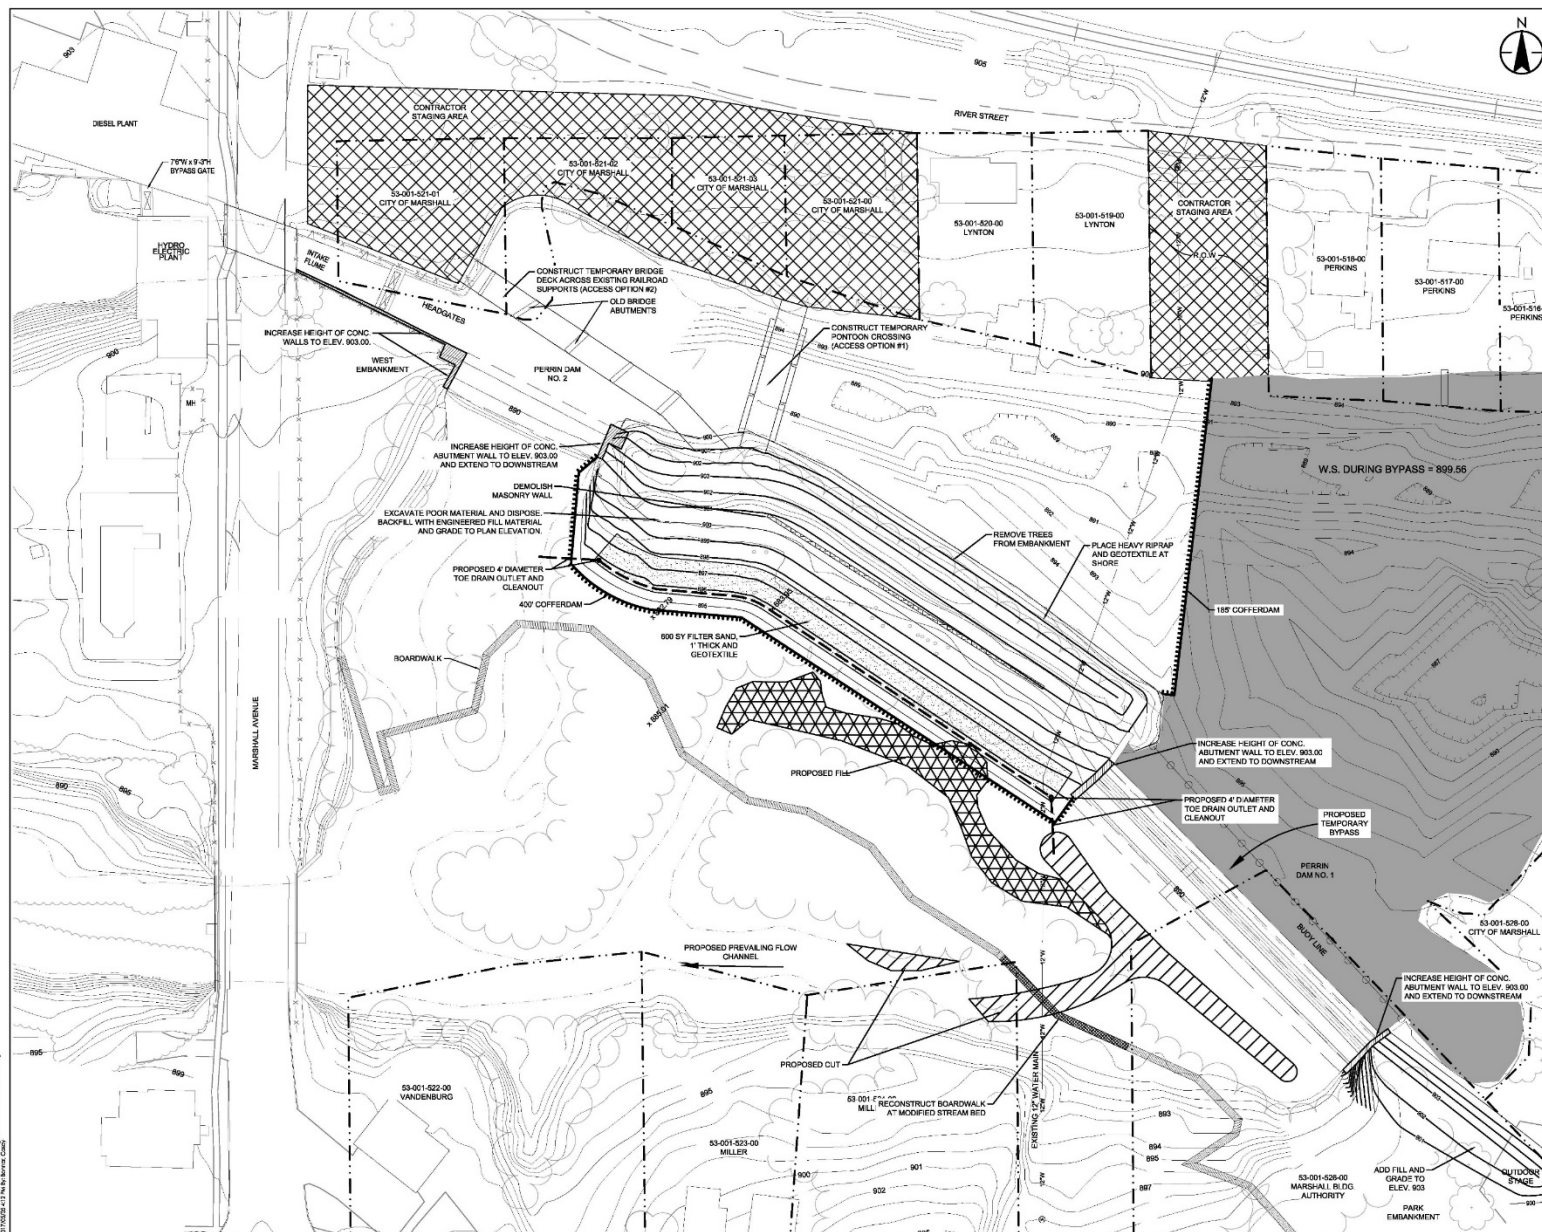
Figure D.4

Title
COFFERDAM - ALTERNATIVE 2

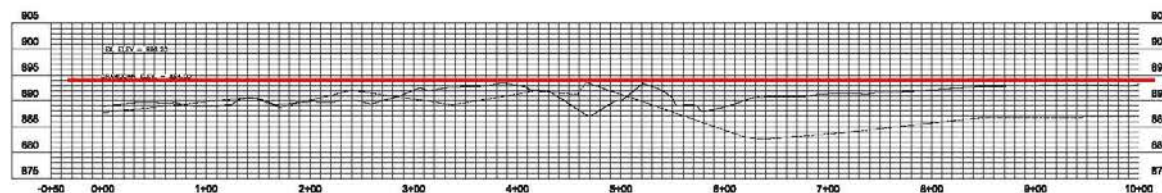
400' upstream

Repair with drawdown

TOTAL IMPOUNDMENT LENGTH > 3 miles

Repair with Drawdown
\$22 Million
